Heritage Conservation Plan

Christ Church - Fernie, BC - 1910

Elana Zysblat, CAHP - Ance Building Services :: John Atkin, History + Research
November 2018

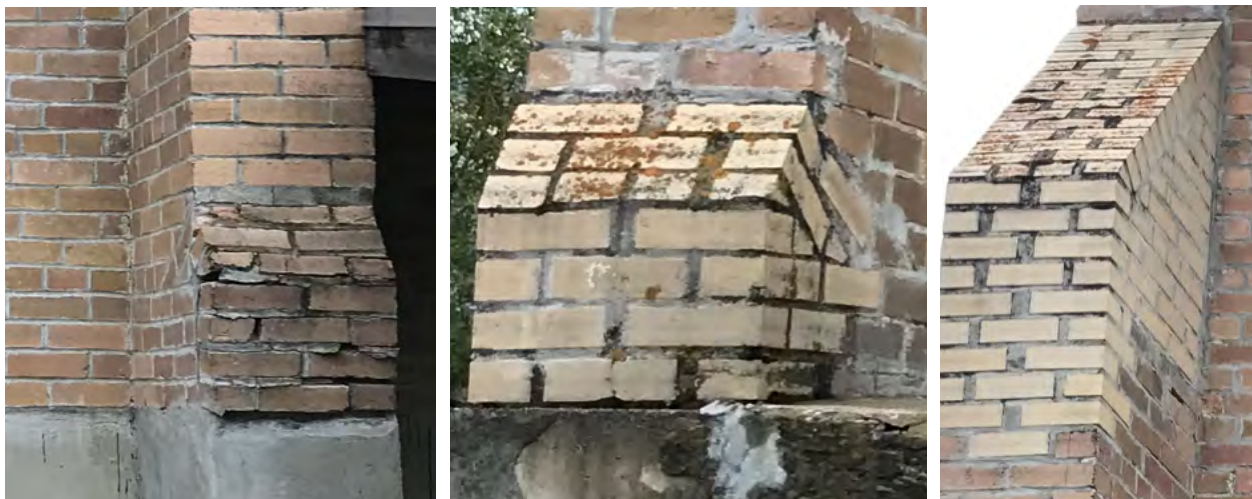
The exterior walls are in generally good condition, though there are specific areas that exhibit some damage, notably the base of the buttresses and the end gables of the east and west faces of the building. Substantial repairs were undertaken in 1996 with the repointing and sealing of the east and south walls of the church. Prior to 1980, repairs were made to some of the bases of the buttresses atop the concrete foundation with a cream coloured brick. For the most part these repairs have failed. Bricks have come loose with broken and heaving mortar, and in some cases this has caused some damage to the concrete foundation. Incompatible mortar used in the repair work along with water from specific points on the roof appears to be the primary cause of failure.

Examples of brick failure and damage due to inappropriate mortar, water. The bricks used in the repairs are not the same dimension as the originals resulting in large mortar joints and inconsistent brick work. What appear to be newer repairs have been sloppily executed.

The loose bricks with broken and missing mortar on the buttress base need to be remediated by rebuilding those areas following the procedure below:

- a. Remove the incompatible mortar currently used
- b. Reset the original bricks using the correct mortar and match the style and width of existing mortar joints

- c. For areas that have been repaired using the cream brick, strong consideration should be given to sourcing bricks that closely match the dimensions and colour of the original Sandpoint bricks. This will eliminate the large areas of mortar between these bricks and the obvious and distracting looking repairs which take away from the church's overall appearance.
- d. The stuccoed columns at either side of the front of the church should not be intervened with, as they are performing well and who knows what the stucco hides.

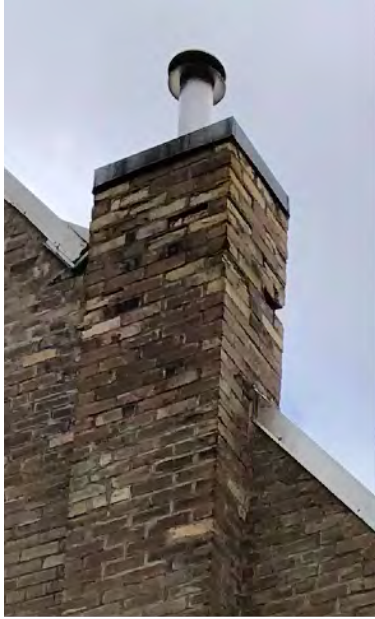
Missing, broken and spalled bricks on the chimney because of incompatible mortar and bad flashing details. Water is directed off the gable against the chimney and the wall resulting in spalling of the brick surface and erosion of the mortar and water stains in the inside wall of the church. (see description of flashing on page 16)

Water damage: The current flashing constructed and installed with numerous seams and attached to the brick with screws is contributing to the damage and staining for both the exterior and interior of the church. The flashing needs to be redone to eliminate the seams with a new cap flashing over brick wall, embedded in brick with gum lip, covering waterproof membrane, made up of a single piece with no seams except upright seams at corners only.

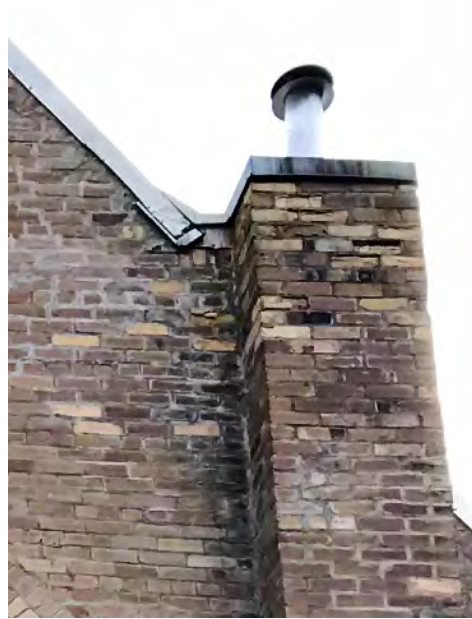
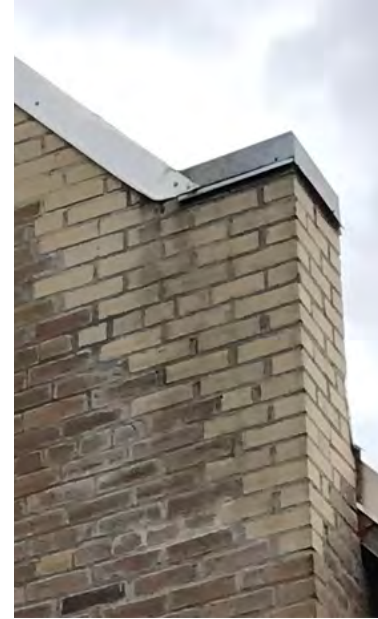
Incorrect installation of flashing on the gable end results in staining and future water damage. (see description of flashing on page 16)

A new roof would allow corrective action to be taken on the flashing details at the gable ends to stop the water damage seen on the exterior and interior of the building.

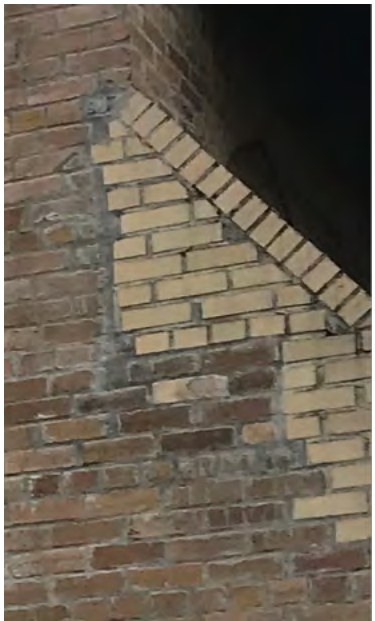
Unsympathetic mortar repairs with wide joints and gaps. Water damage and staining.

The repairs on the gable ends using the cream brick should be examined for loose mortar, gaps and other issues. Strong consideration should be given to rebuilding those areas using a brick that closely match the dimensions and colour of the original Sandpoint bricks. The obvious and distracting looking repairs in such prominent locations take away from the church's overall appearance and heritage value. The repointing in some areas is sloppy with mortar sitting on top of the brick surface and is inconsistent in its application, this needs to be remedied. The mortar should be checked carefully to see how deep the repointing has been as incorrect mortar will cause damage in the future.

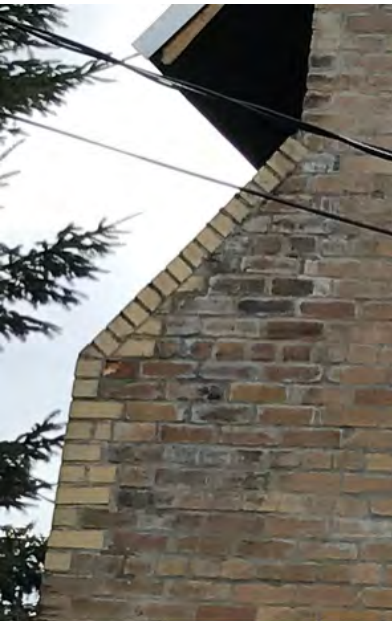
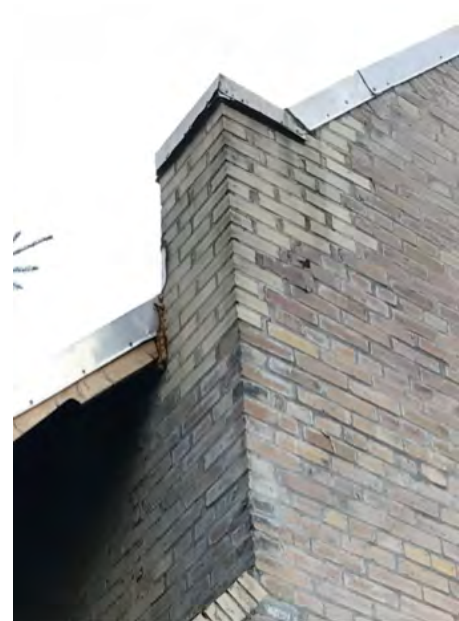
Bad flashing installation sends water down the brick face causing staining, disintegration of the mortar and spalling and cracking of the bricks. (see description of flashing on page 16)

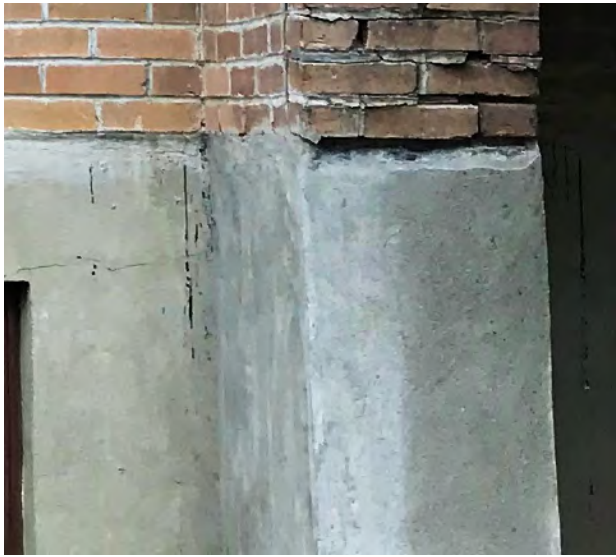
Broken concrete under a failed brick repair on a buttress, a result of water and incompatible mortar stucco

The above ground basement concrete's stucco and its integrity needs to be closely examined by a masonry contractor in light of the variety of patches and the water and staining to ensure it is bonding properly to the concrete.

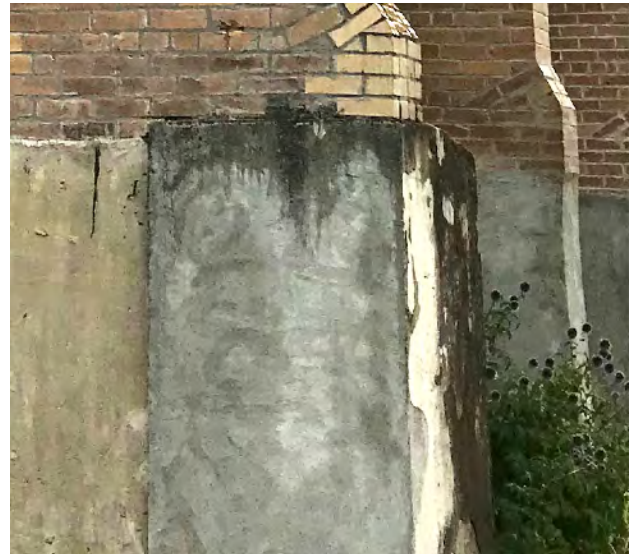
Extensive staining from water on the concrete and a variety of stucco patches on the original foundation

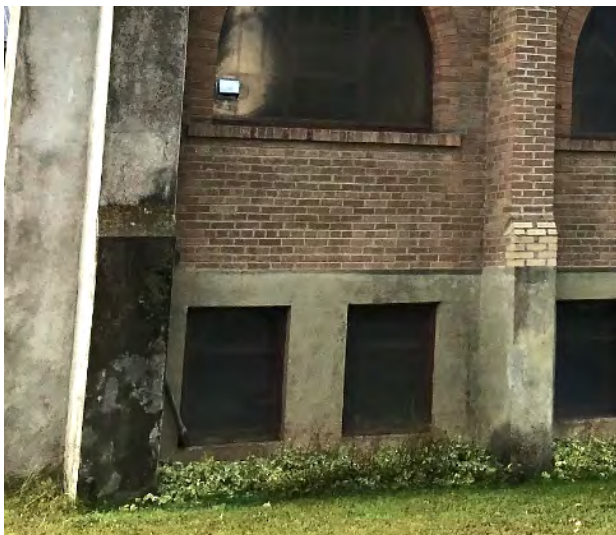
Run off from the roof onto the stuccoed buttresses has caused significant staining

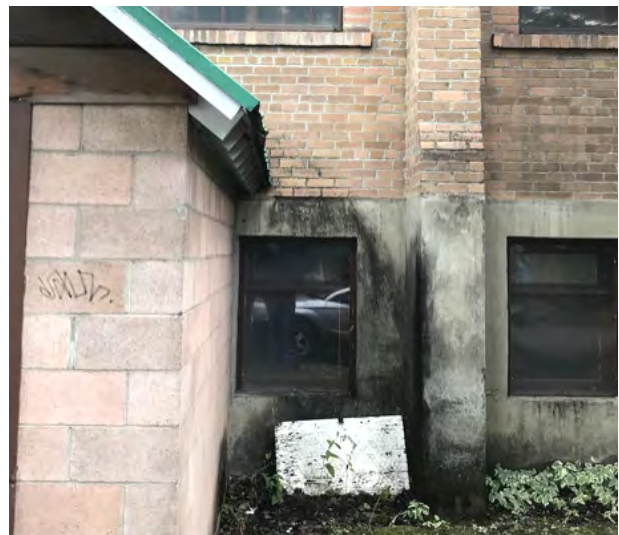
Run off from the roof of the basement fire exit stairs has caused significant staining on the concrete foundation and eroded the mortar of the bricks

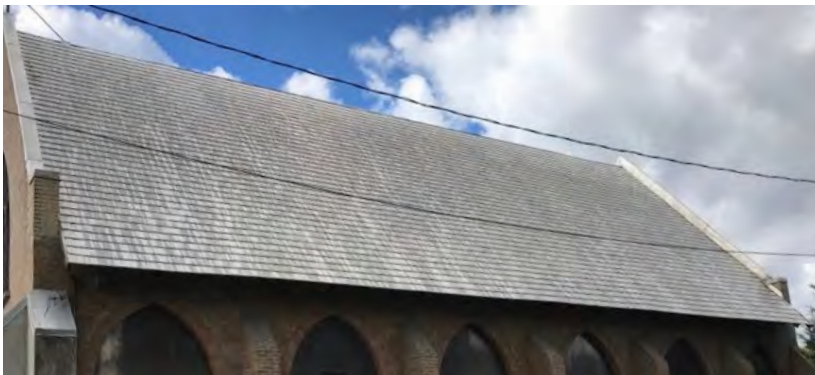
Above: An example of the flashing installation showing the gaps and seams that lead to water penetration of the structure

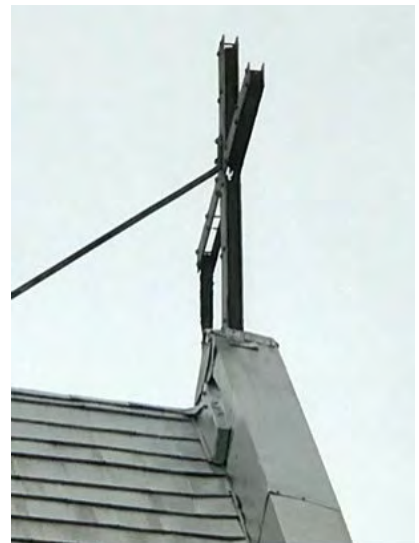
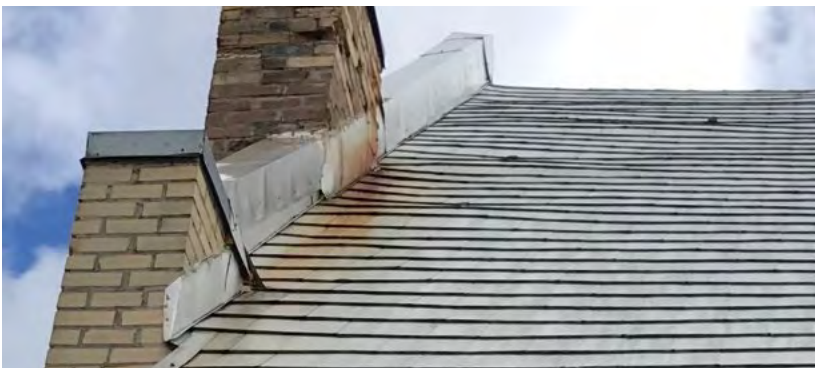
The original slate roof was replaced with the current metal shingles in 1968 and it is showing its age. There is damage along the ridge where the wind has lifted the shingles in places. The cross, a riveted metal construction infilled with wood components has deteriorated and partially disintegrated. Flashing repairs have exacerbated water issues on the exterior and for the interior brick work. The flashing is screwed onto the brick and is made up of several pieces, creating seams which channel the water down the brick face. Additionally the current flashing installation does not take into account the capillary action of water and snow up against the flashing enabling moisture to travel up against the pull of gravity. This action has led to the staining seen on the interior of the church at each of the corners where the brick meets the ceiling - notably where the cream coloured brick repairs have taken place.

Roof damage and the metal cross with missing wood

When built, Christ Church had a slate roof that was replaced in 1968 with the existing metal shingle installation. A new roof needs to be installed. Holy Family Church on the same block offers an example for the new roof with their synthetic roofing slate installed in 2007, using Galveston Light Grey 'full slates' manufactured by Authentic Roof which is made of a proprietary thermo-polymer olefin compound to look like natural slate. (<http://www.authenticroof.com/cms/products/general>)

When redoing the roof, remove the cross temporarily to inspect its condition better. The original plans for the church call for a stone cross at the gable peak which appears to never have been installed. The current metal-clad wood cross illustrates the design specified by Egg & Haldane, but is a much lighter construction. Remove wood portions from the metal-bolted frame and paint the cross with rust-retardant paint. Consider installing LED lights to internally illuminate the metal shell. Ensure the cross is solidly bolted to the new roof. Consider restoring a second cross to the peak of the covered entrance, as seen in the archival photo from 1970.

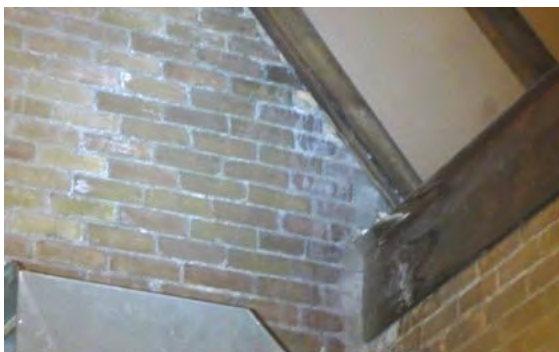
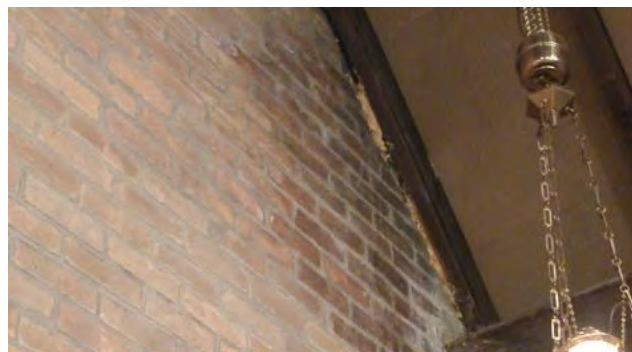
Water staining on the inside walls because of incorrect flashing details on the roof.

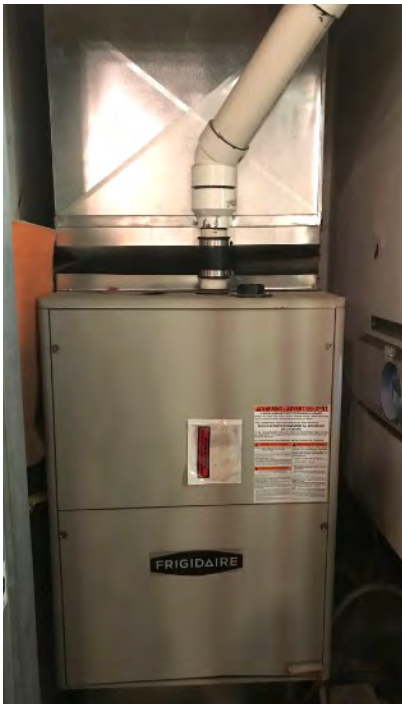
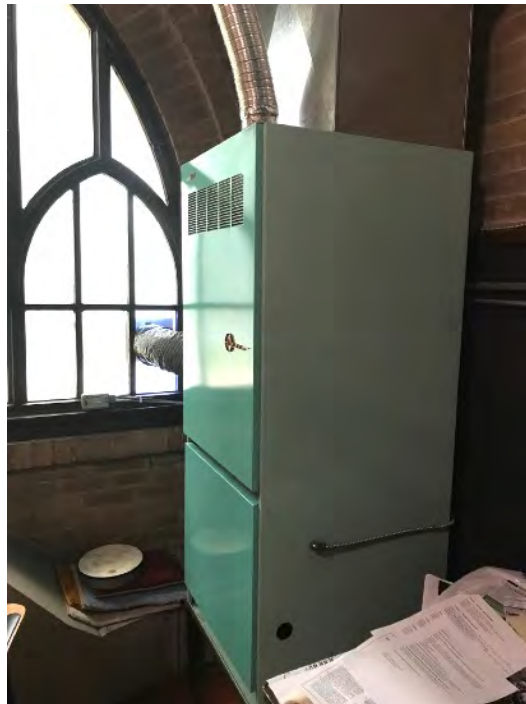
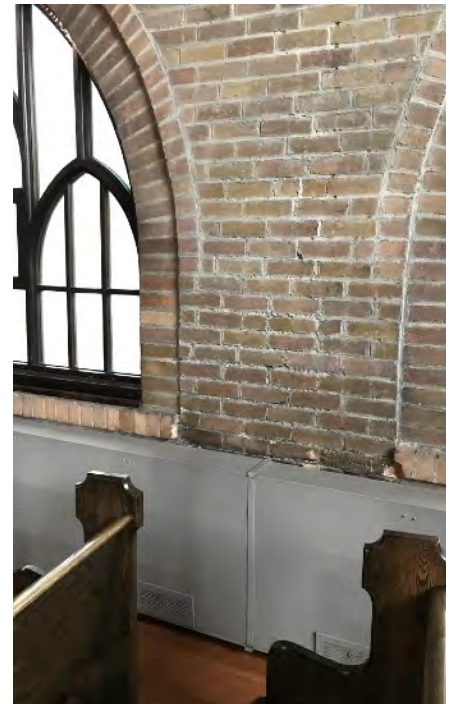
The interior of the church is in good condition and is regularly maintained. There are two forced-air furnaces at the rear of the sanctuary that provide heating but are ineffective overall and are not well integrated into the space. The furnace ducts are large, bulky and a relatively dominant, distracting element in the church's otherwise very historic interior. When operating, the furnaces are noisy and the general sense is that the sanctuary space is uncomfortably cold, notwithstanding the furnaces and the insulated ceiling. Access is made available to the basement and sanctuary by stairs and by an elevator that is housed in an extension of the small entrance vestibule.

Top left: the new, high efficiency furnace installed in the last few years.

Top middle: the older of the two furnaces which live at the back of the church taking up significant space.

Top right: the furnace ducts run along both walls of the nave, taking up room, making noise and not heating the space effectively.

Replace old furnace with high-efficient boiler and install radiators along the south wall in place of the old furnace duct. Radiant heat is the original form of heating for this building and the only effective method to heat such a large space. Radiant heat is also silent, while the current furnaces are very disruptive to the churches activities and services. Consider installing a boiler that will have the capacity to heat the north side as well when the newer furnace comes to the end of its life. When the second furnace needs replacing, convert the north side to radiators as well.

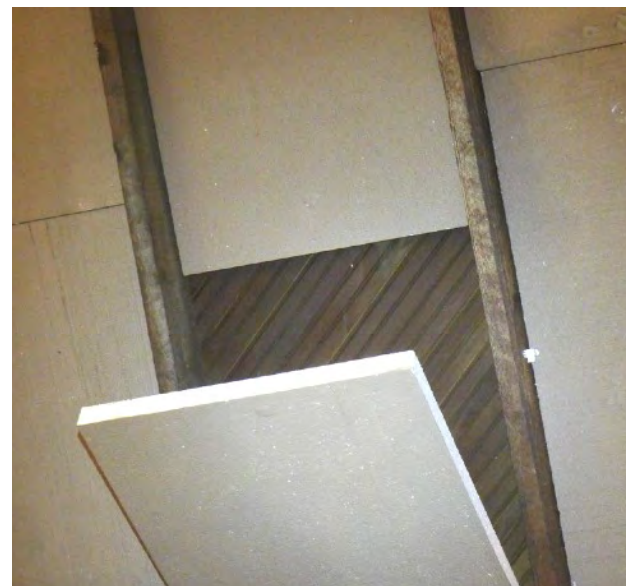
Bottom: a 'sneak-peek' of the tongue & groove ceiling under the foam panels.

Restore the visibility of the original wood ceiling by removing the foam panels, once one of the furnaces is replaced with a boiler. Reuse foam panels in other church projects.

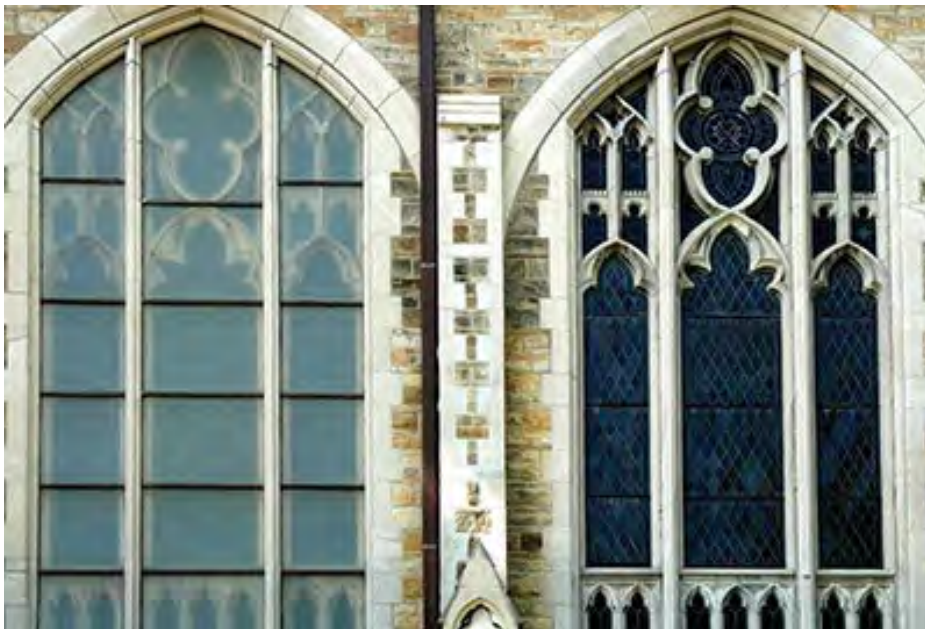
A common error in installing protective glazing is to create a new window configuration (see photo above). Insensitive installations that disregard the original tracery destroy the window's aesthetics—and the building's. On this pair of neo-gothic church windows, the aluminum frame grid used for protective glazing disregards the original tracery of the window on the left. The grid mars the appearance of the window inside and out. It also impairs the overall historic character of the building. The plastic storm glazing has been removed from the adjacent window to restore the original window appearance. When protective glazing is added, it should be ventilated. If a window is not ventilated, heat and condensation may build up in the air space between the ornamental glass and the protective glazing (creating a "greenhouse effect").

Protective glazing should be installed in an independent frame between $\frac{5}{8}$ " (16mm) and 1" (25mm) from the historic glass. This allows the protective panel to be removed for periodic maintenance of both the historic window and the new glazing. The conditions of the air space
