Heritage Conservation Plan

Christ Church Rectory 561 4th Avenue, Fernie BC - 1909

Elana Zysblat, CAHP - Ance Building Services :: John Atkin, History + Research

November 2018

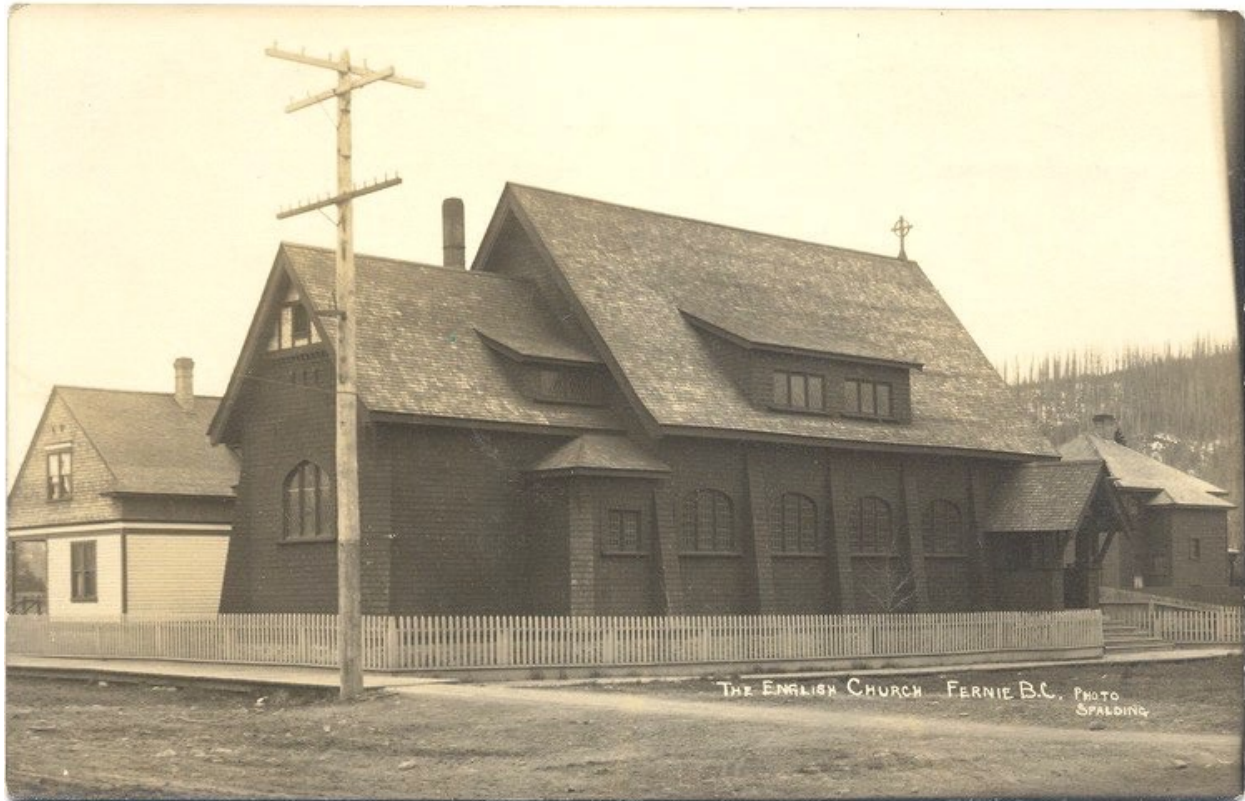
Postcard photographed by Spalding of the second Christ Church in Fernie constructed in 1905 and destroyed by fire in 1908, with rectory next door, both standing in the location of today's church and rectory. Source: Fernie Museum 3712

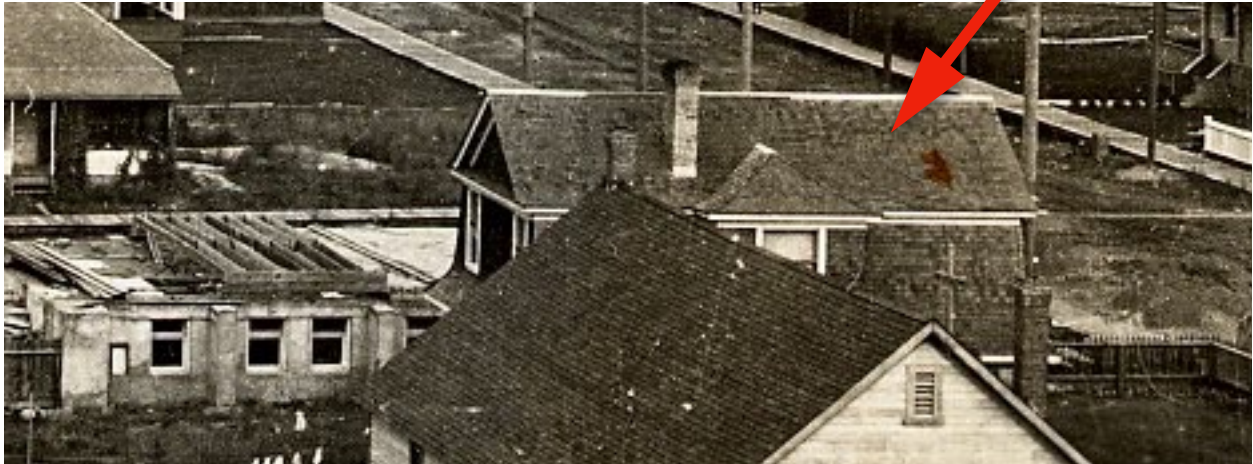
There are no known photographs of the rectory except where it has been caught on the edge of photographs taken of other buildings. The above image was taken in 1909 from the roof of the Catholic Church temporary church and shows a portion of the south side and rear of the rectory.

Top: the basement of Christ Church under construction in 1909, and the rectory, marked with an arrow already completed. Source: Fernie Museum 0103-01

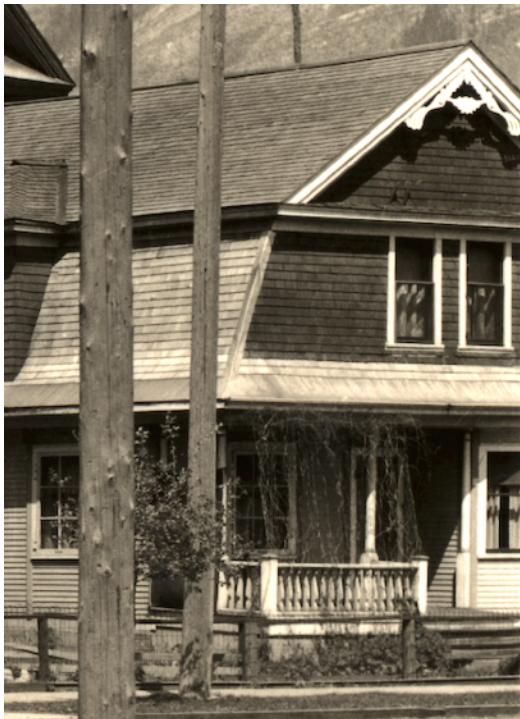
When Knox Church was photographed in the 1930s (left) their MMM rectory was captured in the frame and clearly shows the porch details, window arrangement, fretwork in the gable and the general colour scheme of a dark upper body with the lighter base.

Bottom: Knox United rectory - photographed between 1936 and 1942. Source: Fernie Museum & Archives FMP09414A

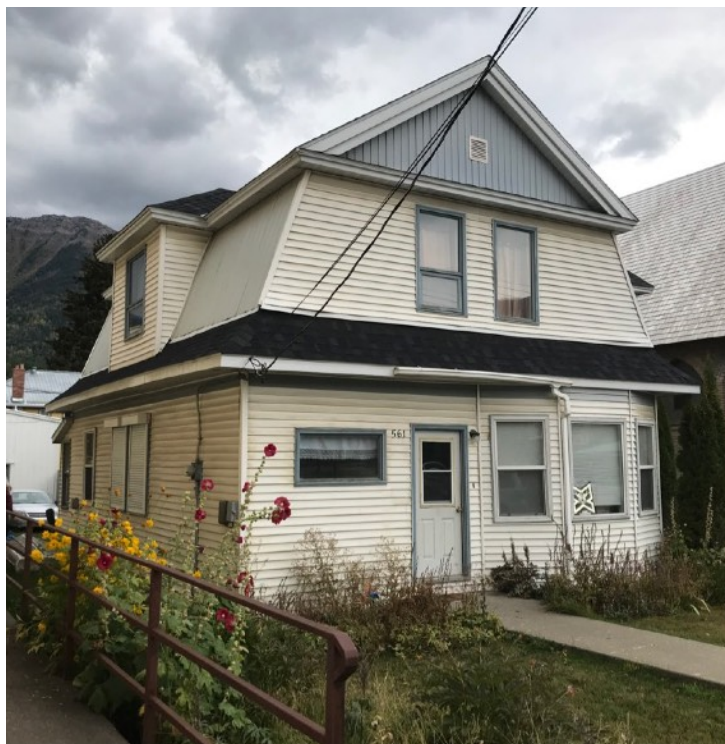
Top left: the front of the house facing 4th Avenue

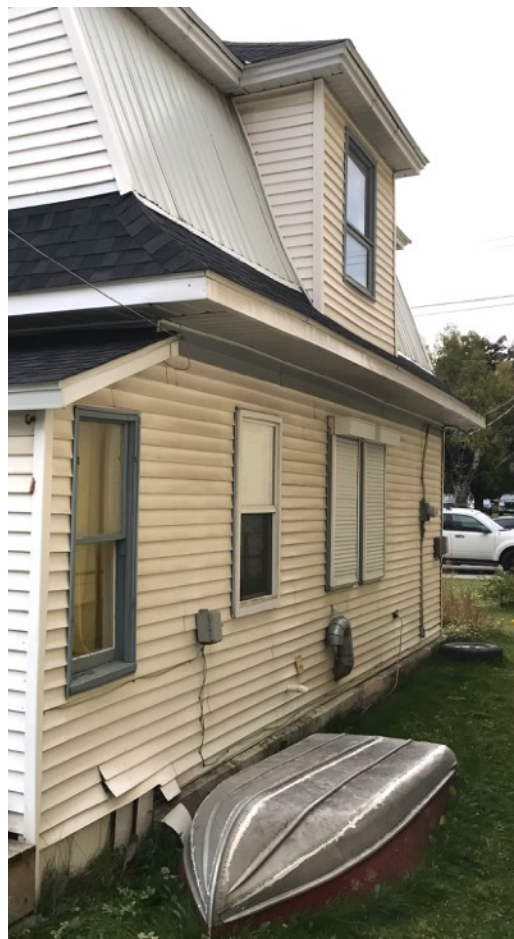
Top right: south side of the house

Overall the house is in good condition. There is some loose vinyl siding on the south side along the top of the foundation. Paint is needed on all of the wood work and the relocated front door. The rear enclosed porch needs some carpentry attention.

Woodwork including window trim and the original front door (at the rear of the house) should be painted. Loose vinyl siding should be reattached and any opening around the foundation and rear deck should be sealed.

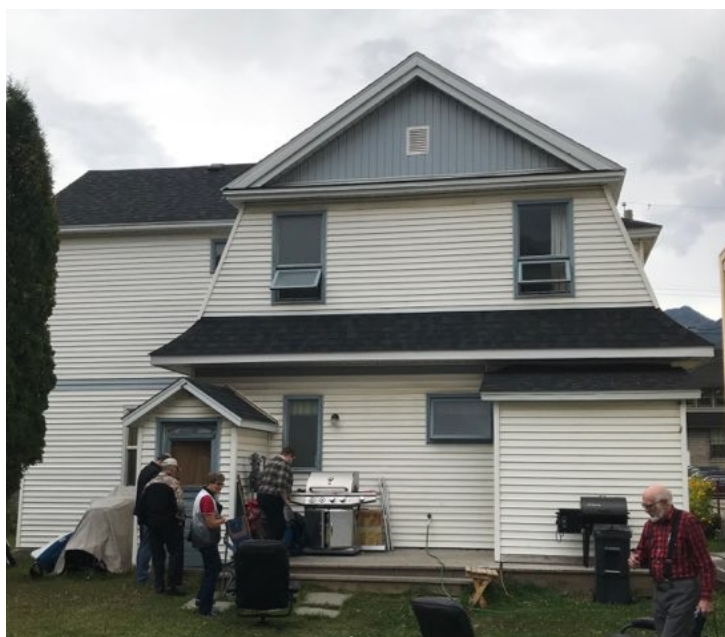
Bottom left: rear of the house

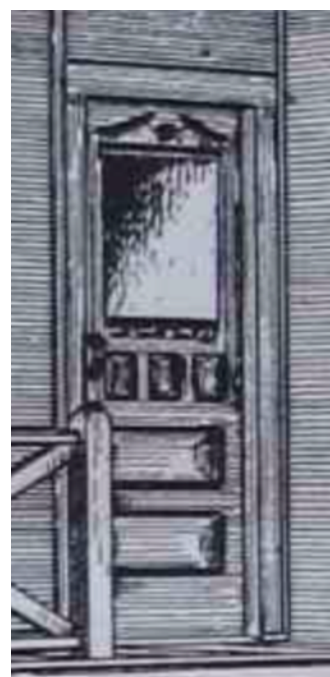
Bottom right: the front door as seen in the 1905 catalogue

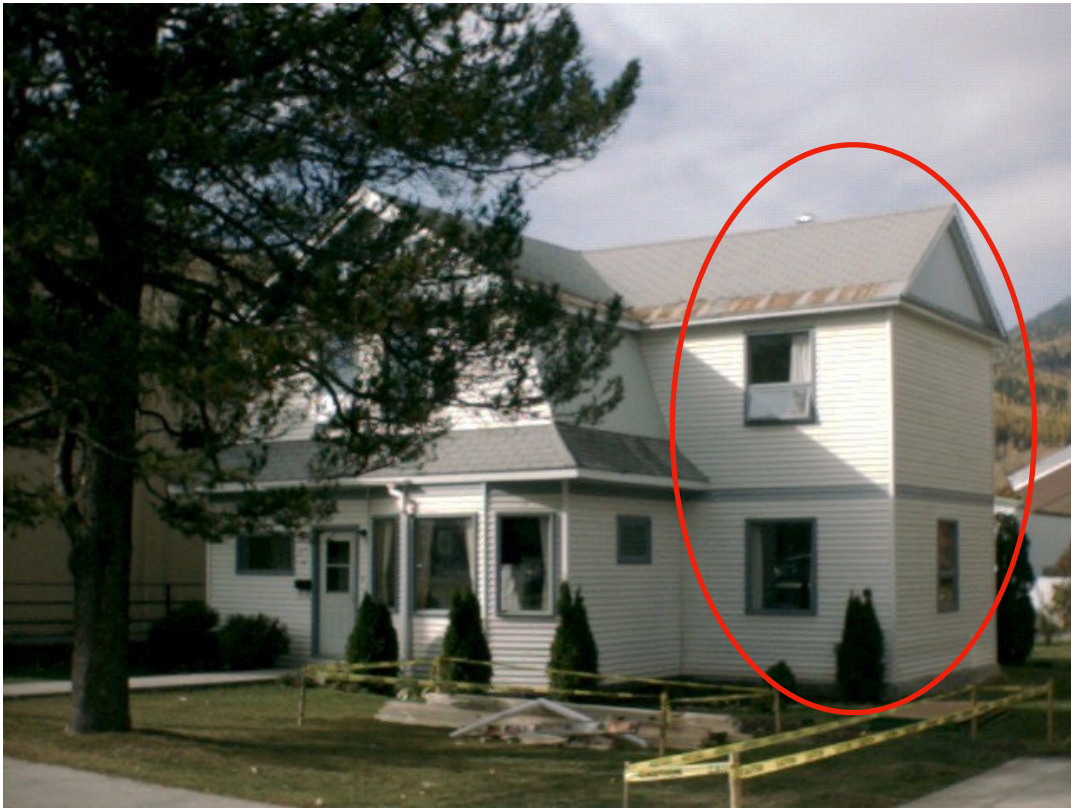
Photo of the front of the rectory showing the 1917 addition circled

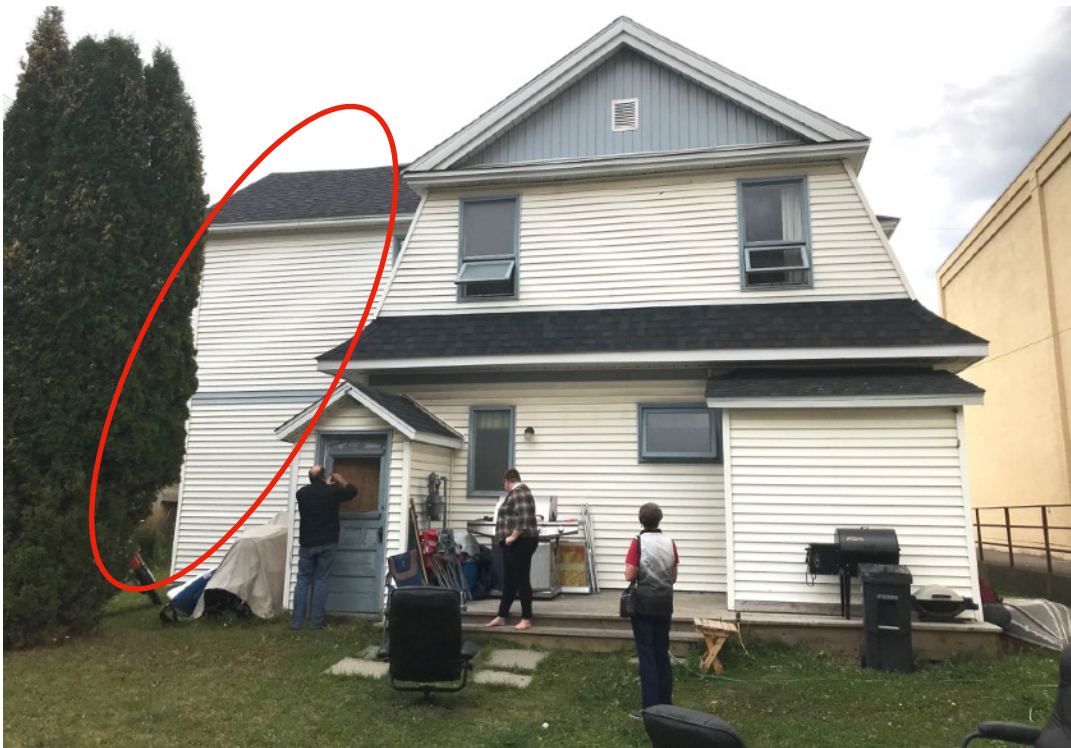
Photo of the back of the rectory showing the 1917 addition, and the current location of the original wood front door, now serving as a door to the basement.

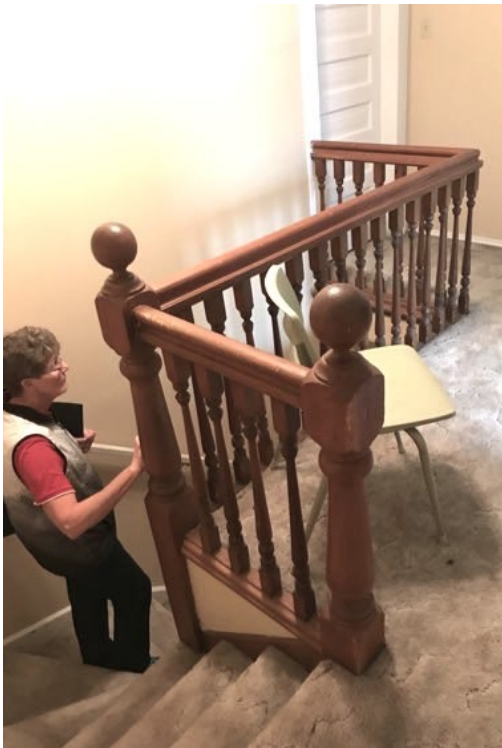
Left: Original balustrade and staircase on the interior of the rectory.

While the interior has been renovated much of the trim, moulding and doors have survived and these should be maintained as Character Defining Elements.

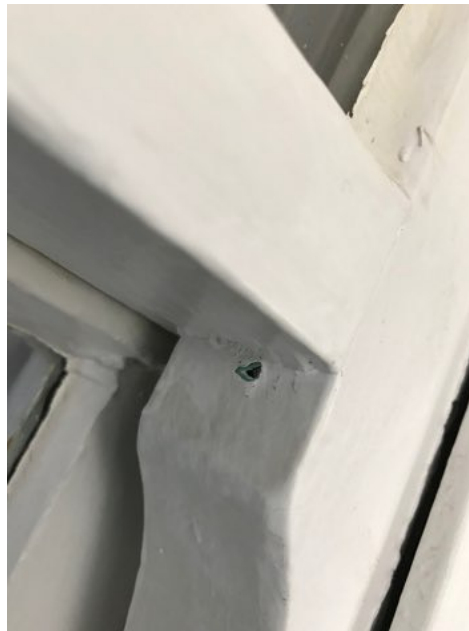
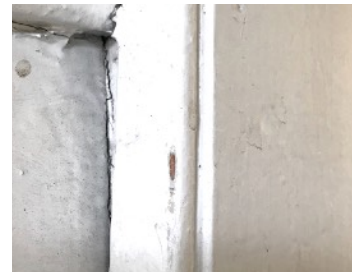
Middle and right: The few original wood windows and exterior trim pieces can be scraped down to find the original colour scheme. At first glance the windows and doors appear to have been a very dark, almost black green and the trim was painted in cream.
