Heritage Conservation Plan

Christ Church - Fernie, BC - 1910

Elana Zysblat, CAHP - Ance Building Services :: John Atkin, History + Research
November 2018

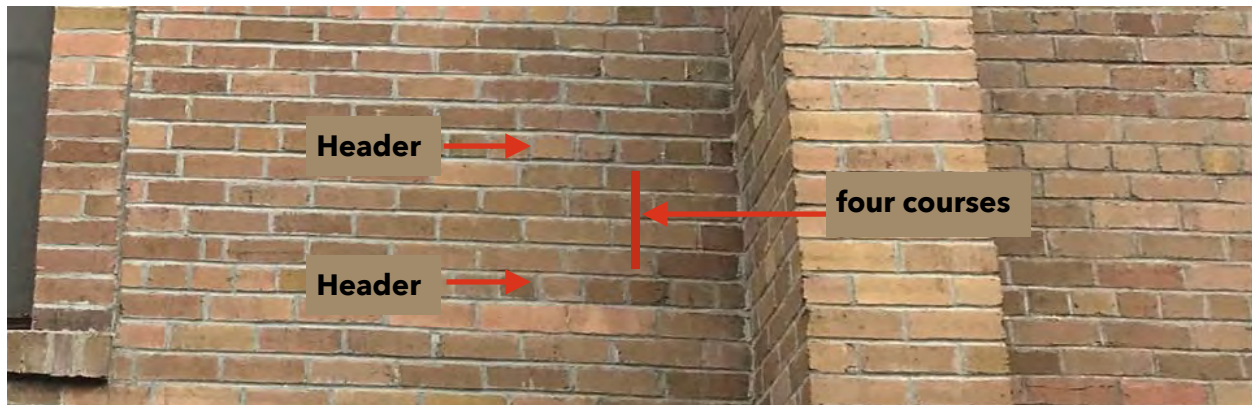
The exterior walls are in generally good condition, though there are specific areas that exhibit some damage, notably the base of the buttresses and the end gables of the east and west faces of the building. Substantial repairs were undertaken in 1996 with the repointing and sealing of the east and south walls of the church. Prior to 1980, repairs were made to some of the bases of the buttresses atop the concrete foundation with a cream coloured brick. For the most part these repairs have failed. Bricks have come loose with broken and heaving mortar, and in some cases this has caused some damage to the concrete foundation. Incompatible mortar used in the repair work along with water from specific points on the roof appears to be the primary cause of failure.

The loose bricks with broken and missing mortar on the buttress base need to be remediated by rebuilding those areas following the procedure below:

- c. For areas that have been repaired using the cream brick, strong consideration should be given to sourcing bricks that closely match the dimensions and colour of the original Sandpoint bricks. This will eliminate the large areas of mortar between these bricks and the obvious and distracting looking repairs which take away from the church's overall appearance.
- d. The stuccoed columns at either side of the front of the church should not be intervened with, as they are performing well and who knows what the stucco hides.

The repairs on the gable ends using the cream brick should be examined for loose mortar, gaps and other issues. Strong consideration should be given to rebuilding those areas using a brick that closely match the dimensions and colour of the original Sandpoint bricks. The obvious and distracting looking repairs in such prominent locations take away from the church's overall appearance and heritage value. The repointing in some areas is sloppy with mortar sitting on top of the brick surface and is inconsistent in its application, this needs to be remedied. The mortar should be checked carefully to see how deep the repointing has been as incorrect mortar will cause damage in the future.

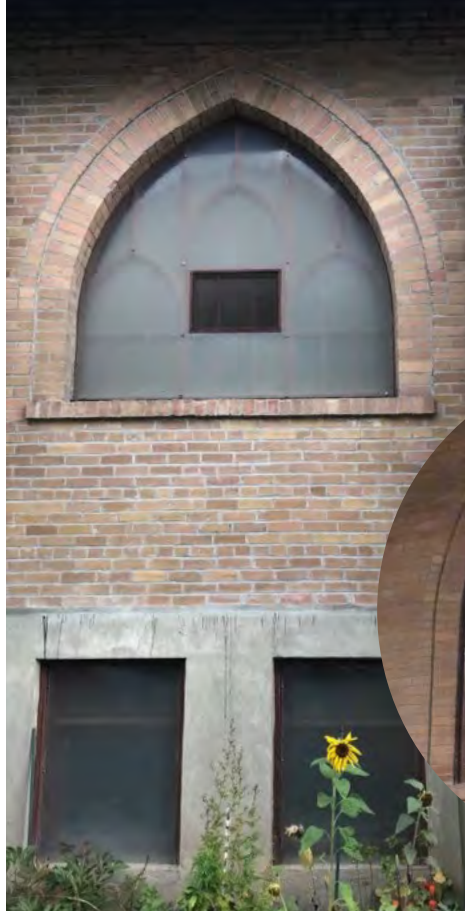
Water staining on the inside walls because of incorrect flashing details on the roof.

Water damage: The current flashing constructed and installed with numerous seams and attached to the brick with screws is contributing to the damage and staining for both the exterior and interior of the church. The flashing needs to be redone to eliminate the seams with a new cap flashing over brick wall, embedded in brick with gum lip, covering waterproof membrane, made up of a single piece with no seams except upright seams at corners only.

A new roof would allow corrective action to be taken on the flashing details at the gable ends to stop the water damage seen on the exterior and interior of the building.

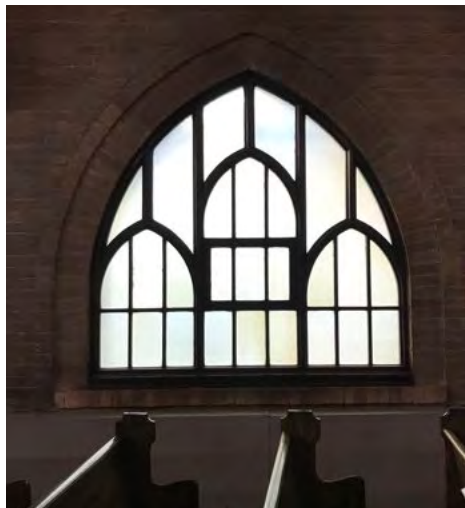
The wood Gothic tracery windows in the sanctuary are in good condition. They are covered with Lexan protective panels screwed into the woodwork. Every window has an awning style opening in the centre but the Lexan has been cut to facilitate the operation of alternating windows. The panels appear to be in good shape though they have discoloured with the exposure to the sunlight, but don't appear to have caused any problems for the historic wood windows of Christ Church.
